**Inspection Report
for
Rainey Ranch
1035 Horse Creek Rd.
Horse Creek, CA, 96050
41.8254° N, 123.0035° W**

Inspection Narrative

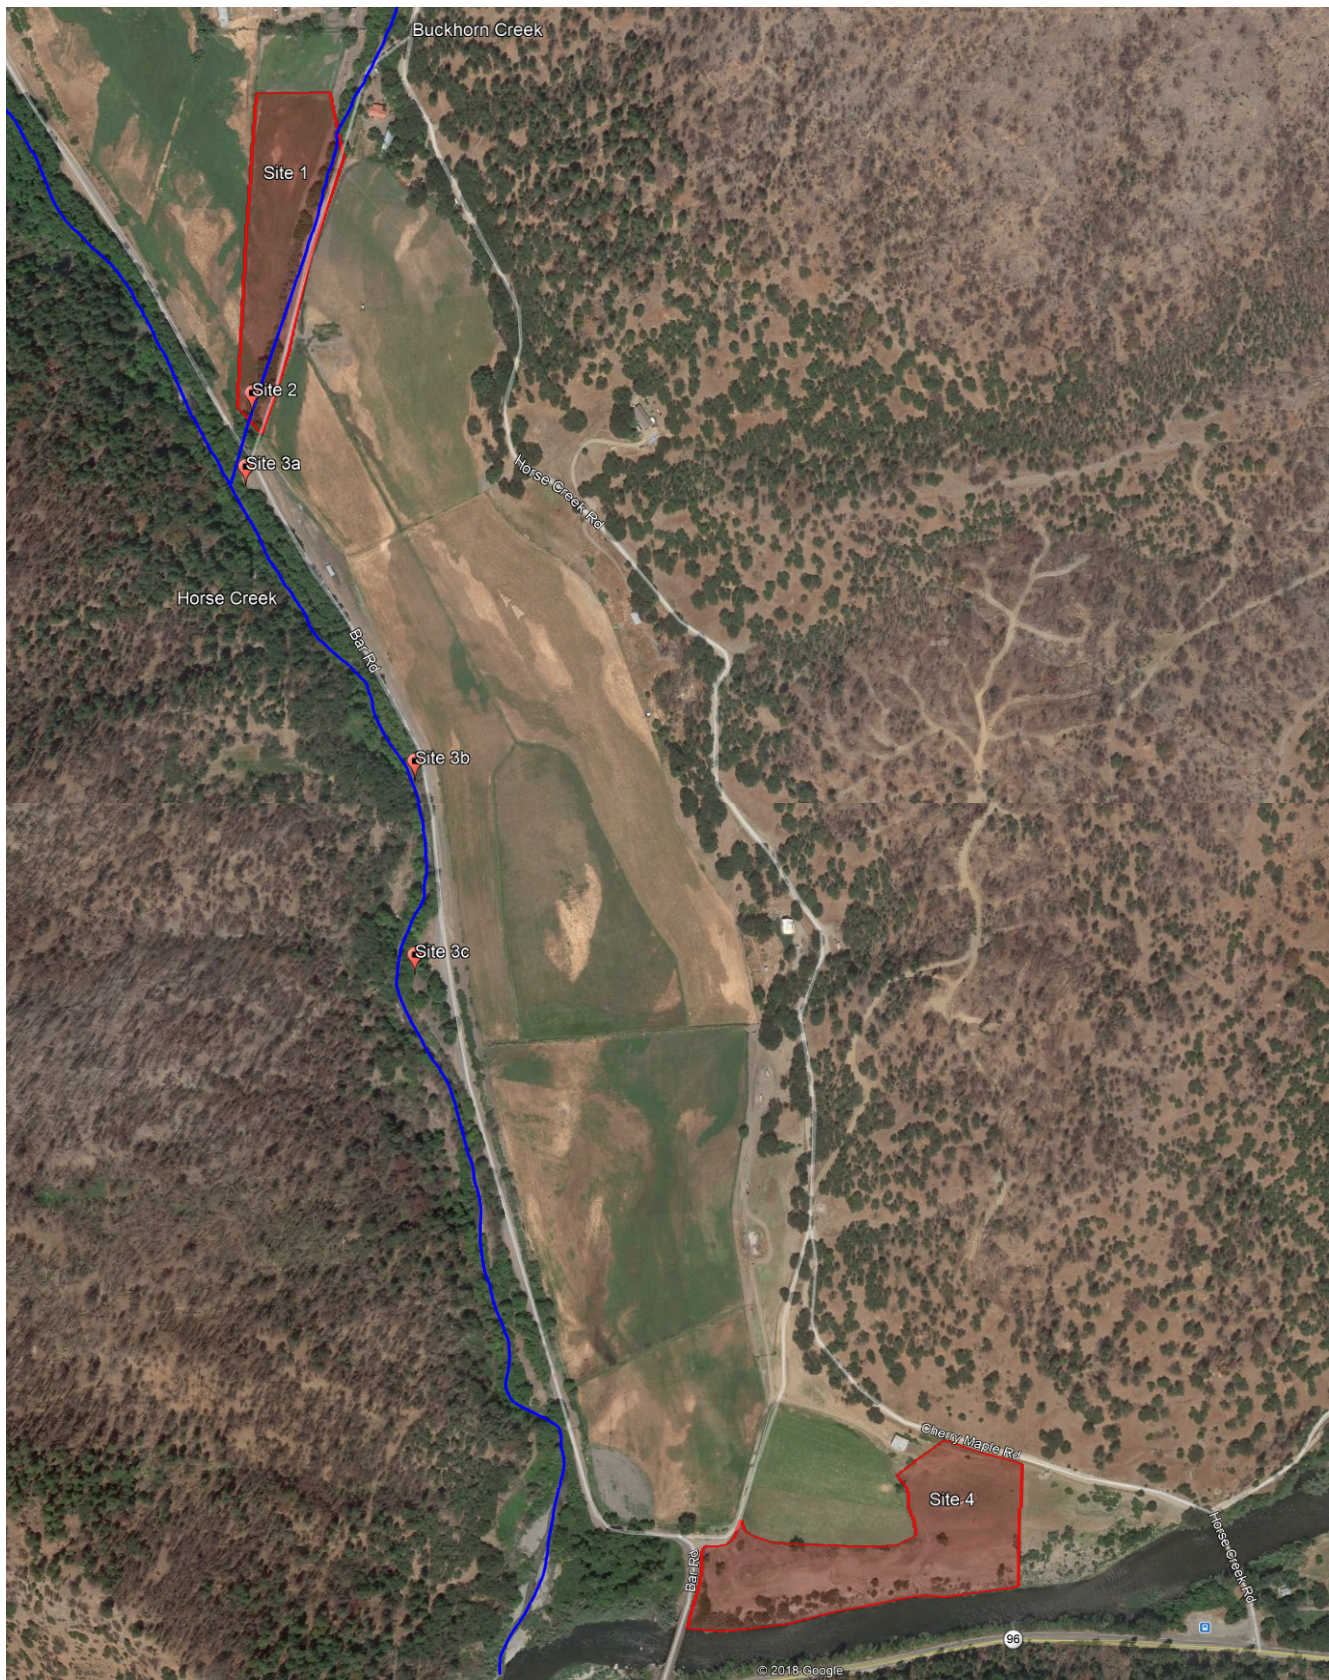
Regional Water Board staff focused the inspection on areas of the ranch where current ranching practices cause cattle to interact with surface waters, including: a pasture where livestock have unrestricted access to approximately 700 feet of Buckhorn Creek (Site 1); a cattle ford/watering area at the lower reach of Buckhorn Creek (Site 2); three cattle bed-down areas within the riparian corridor of Horse Creek (Sites 3a, 3b, and 3c); and a pasture adjacent to, and within the floodplain of, the Klamath River that is used as a feeding lot (Site 4). See Table 1 for a description of the inspection sites and the attached Inspection Map for the site locations.
